2018 Aquatic Plant Management Report

Hamilton Reservoir

Holland, Massachusetts

Report Prepared by: SOLitude Lake Management
590 Lake Street
Shrewsbury, MA 01545

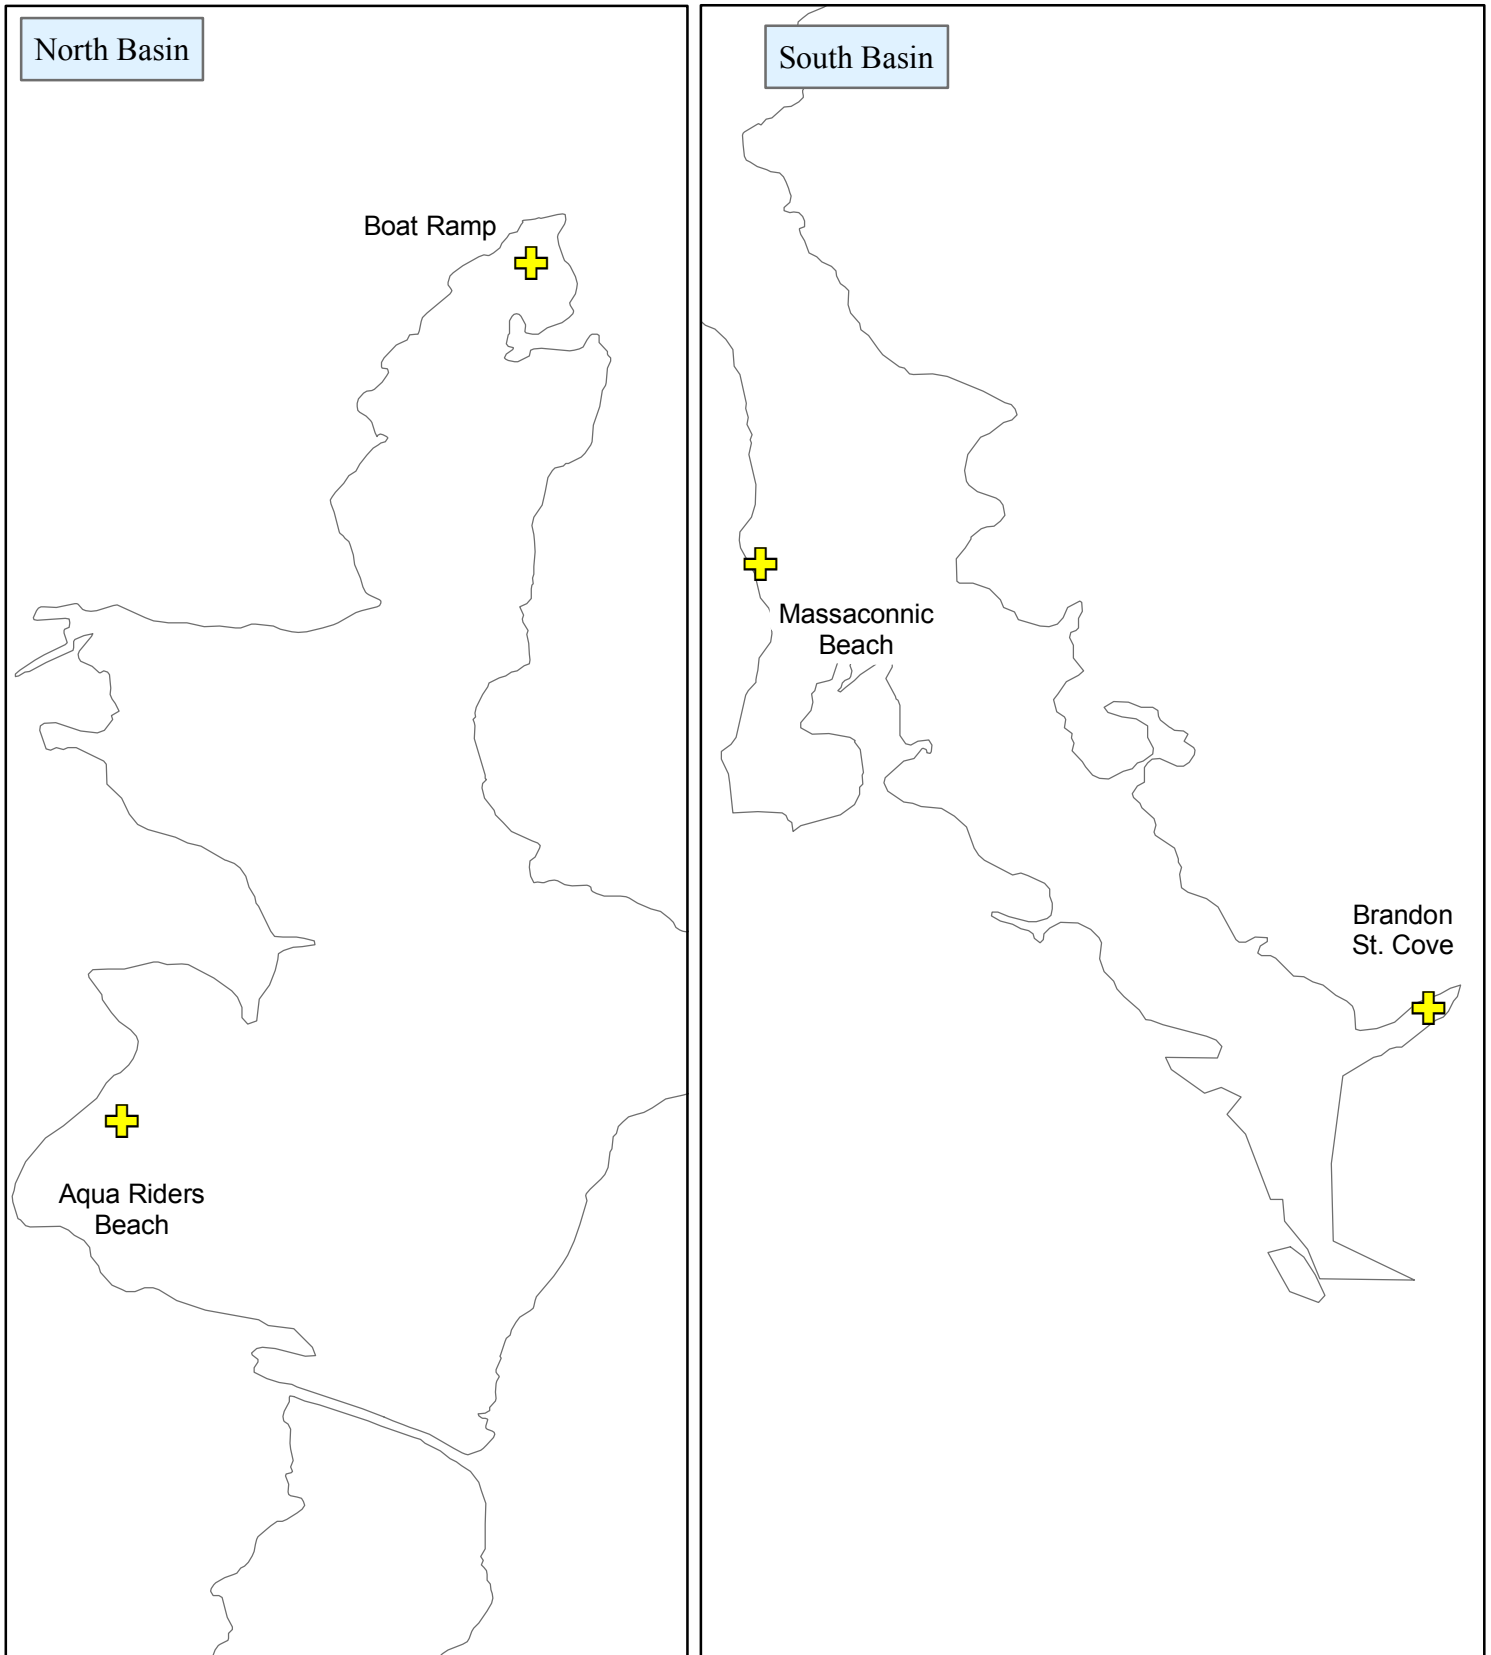
FIGURE 6: Water Quality Stations of North and South Basin

A single water quality sampling round was conducted on July 24th during the mid-season inspection. Samples were collected at four locations for the specific parameters. Please refer to table 1 & 2 for results. Descriptions for the parameters collected are attached (**Water Quality Parameter Explanations**). Please refer to **Figure 6** for water quality sampling locations.

It is also recommended that a proper water quality program be implemented for the 2019 season. It is suggested that water samples be collected at three times during the growing season, May, July, and September to gain a broad understanding of water chemistry throughout the summer months. It is also suggested that three algae samples be tested for identification and enumeration three times during the growing season to determine if nuisance algae and/or cyanobacteria exists in Hamilton Reservoir.
